# Manhole Inspection Summary

Manhole # S39WW\_036MH

Insp Date: **12/18/06 12:48 PM**

**Location** Address: **728 HOMESTEAD ST**

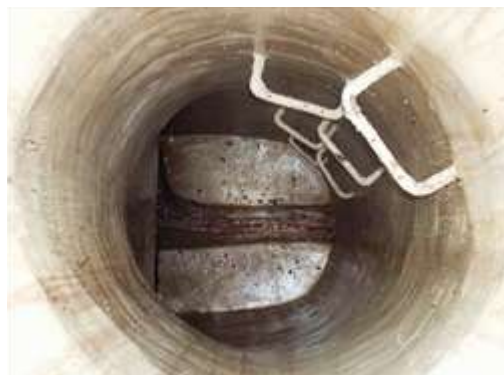
Top View

Infiltration: ☐ None ☒ **Joint** ☐ Cracks ☐ Mortar ☐ Roots ☒ **Wall**

Corbel infiltration.

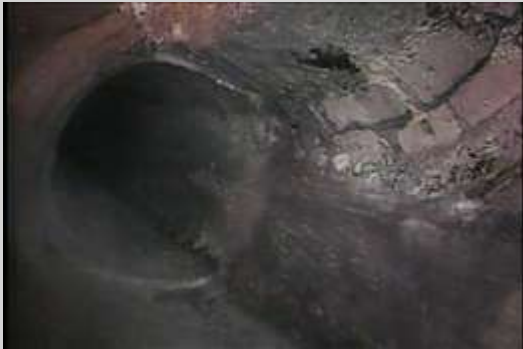
### 15 in. Circular Gravity Sewer Pipe Out @ 12 O'Clock

Pipe Material: **Clay** ☐ Pipe Lined

Invert Depth: **12.04** (ft.) Flow Characteristics: **Fast**

Infiltration: **None** Pipe Seal Cond: **Unknown**

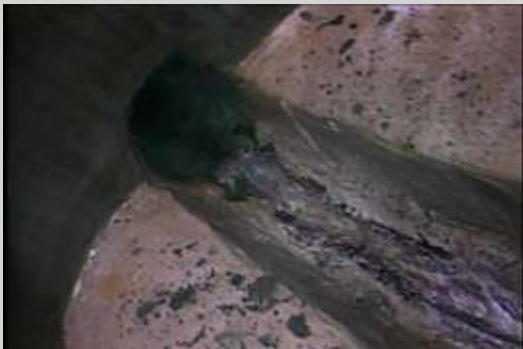
### 8 in. Circular Gravity Sewer Pipe In @ 3 O'Clock

Pipe Material: **Clay** ☐ Pipe Lined

Invert Depth: **11.24** (ft.) Flow Characteristics: **Fast**

Infiltration: **None** Pipe Seal Cond: **Unknown**

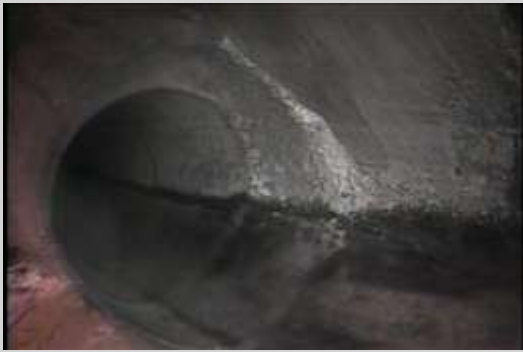
Pipe In @ 6 O'Clock

Pipe Material: **Clay** ☐ Pipe Lined

Invert Depth: **11.97** (ft.) Flow Characteristics: **Slow**

Infiltration: **None** Pipe Seal Cond: **Unknown**

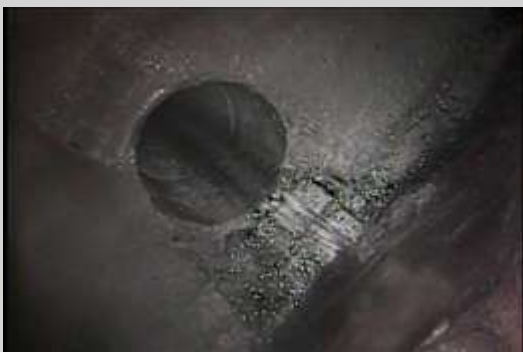
Pipe In @ 9 O'Clock

Pipe Material: **Clay** ☐ Pipe Lined

Invert Depth: **11.56** (ft.) Flow Characteristics: **Slow**

Infiltration: **None** Pipe Seal Cond: **Unknown**
